## Case Study

### Hodgson Funeral Home

Investigate and resolve cause of flooding basement

Crawford replaced 2" main water service

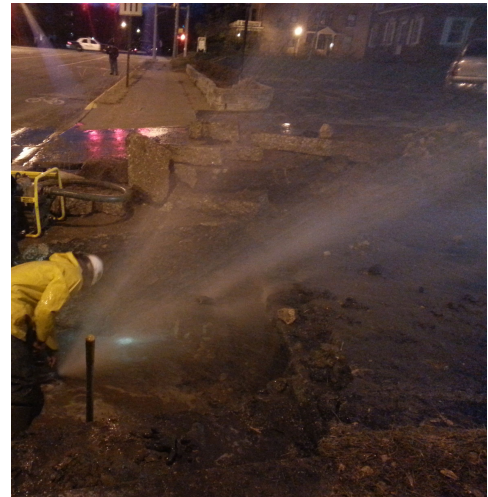
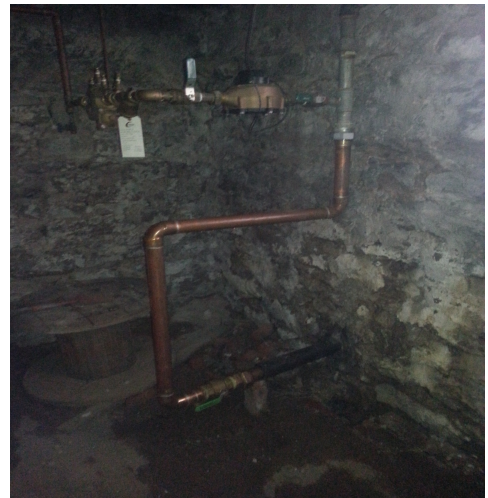
Upon investigating the cause of the flooding it was determined that the 2" main water service had failed and broken near the foundation of the building. The adjoining parking lot was excavated to access the water line. This work required that the street be barricaded and traffic detoured.

Crawford's Plumbing Division replaced the old water service with a new 2" copper line. The damaged water heater was also replaced.

Crawford's HVAC Division quickly repaired the boiler, returning heat to the building and preventing frozen pipes.
