## Case Study

### Hyatt House/Hyatt Place

Commercial HVAC and Welded Fabrication

Provide complete HVAC package for construction of new hotel.

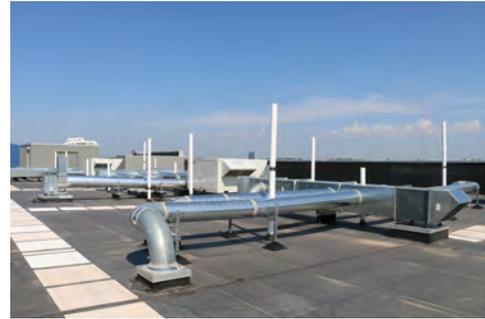
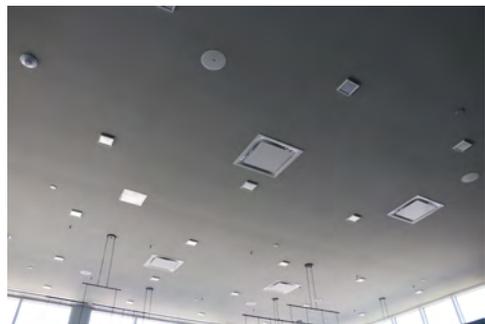
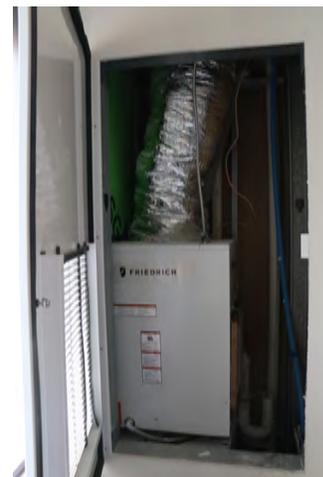
Starting from the top down, the Sky Lounge was furnished with a large roof top unit. It is fully ducted above a hard lid ceiling, and trimmed out with linear diffusers that feed the perimeter, to provide conditioning to the space in and around the large windows.

Throughout the upper corridors and first floor, are two dedicated outdoor air units that provide fresh air to the building. Each suite is outfitted with a Friedrich VTAC unit, and thermostat that conditions the space. All VTAC units have an exterior grill, powder coated to match the exterior section to which it is attached. A Broan bath fan was installed in each suite's bathroom.
